# Manhole Inspection Summary

Manhole # S13QQ1013MH

**Location** Address: **4923 POE AVE**

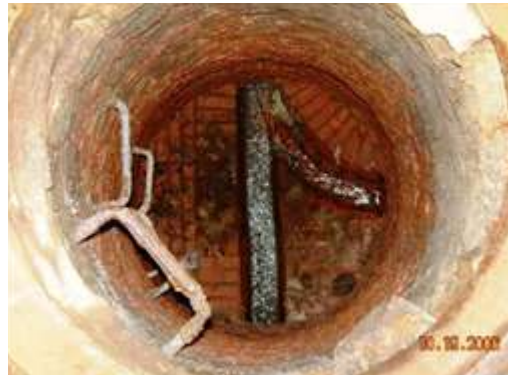
Top View

☐ Parged ☒ **Debris** (not Condition related)

Count: **5** Missing: **0** ☒ **Corroded**

Corroded steps. Bench debris.

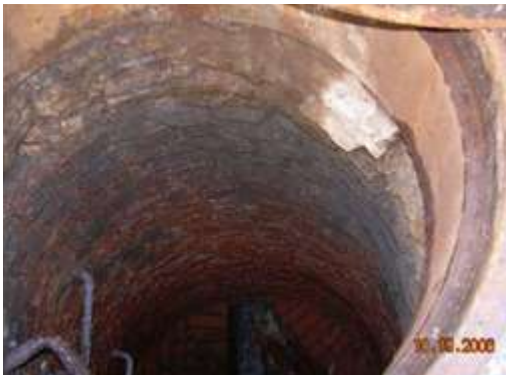
Defect

Condition: ☐ Sound ☐ Cracked ☐ Root Intrusion ☒ **Loose Brick** ☐ Deteriorated

Infiltration: ☐ None ☒ **Joint** ☐ Cracks ☒ **Mortar** ☐ Roots ☐ Wall

Infiltration: ☐ None ☐ Joint ☐ Cracks ☒ **Mortar** ☐ Roots ☒ **Wall**

Adjustment loose brick, deterioration, and infiltration. Corbel infiltration - other side.

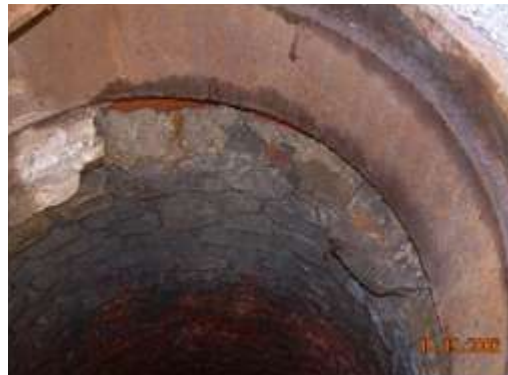
Defect

Adjustment loose brick, deterioration, and infiltration. Corbel infiltration.

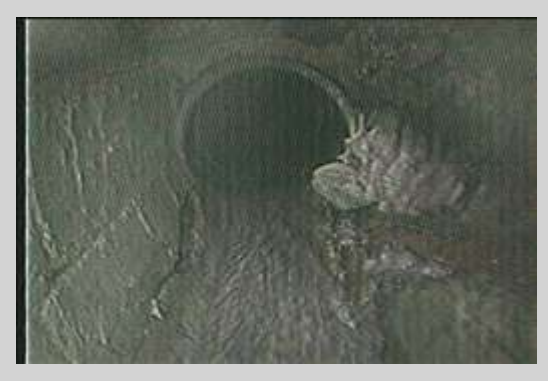
### 8 in. Circular Gravity Sewer Pipe Out @ 12 O'Clock

Condition: ☐ Sound ☒ **Cracked** ☐ Root Intrusion ☒ **Deteriorated** ☐ Leaks ☐ Debris

Channel deterioration and cracks.

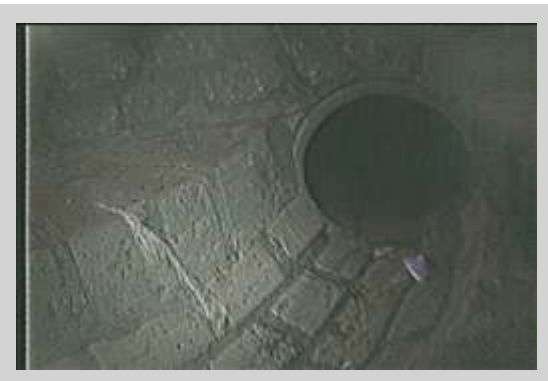
### 8 in. Circular Gravity Sewer Pipe In @ 3 O'Clock

Infiltration: **None** Pipe Seal Cond: **Cracked**
